Errata sheet LPC11U6x

Rev. 1.4 — 7 March 2018

| Info | Content |
|---|--|
| Abstract | This errata sheet describes both the known functional problems and any deviations from the electrical specifications known at the release date of this document. Each deviation is assigned a number and its history is tracked in a table. |

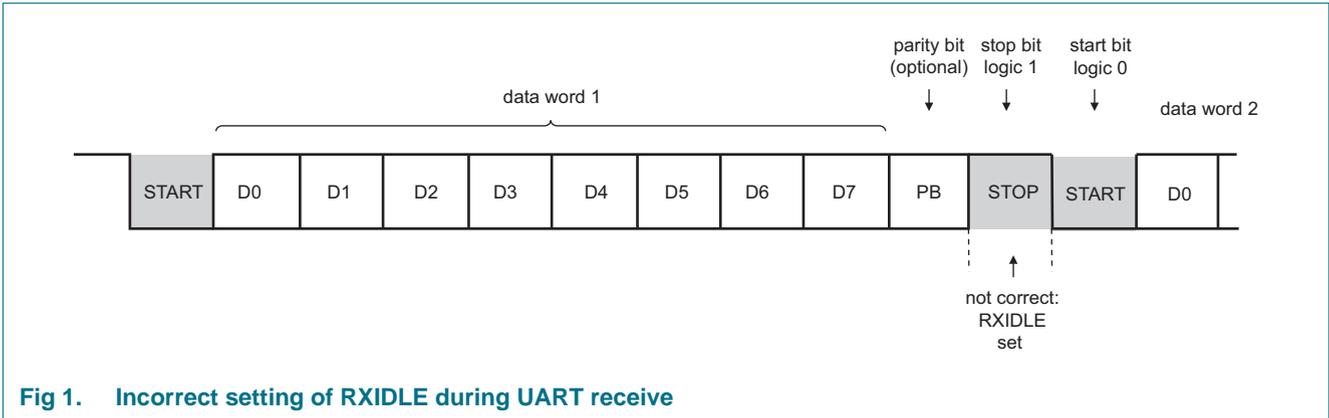
The RXIDLE bit is incorrectly set for a fraction of the clock cycle between the reception of the last data bit and the reception of the start bit of the next word, that is while the stop bit is received. RXIDLE is cleared at the beginning of the start bit.

Fig 1. Incorrect setting of RXIDLE during UART receive

When writing code that checks for the setting of any of the status bits RXIDLE, TXIDLE, TXDISSTAT, check the value of the status bit in the STAT register:

- If status bit = 1, add a delay of one UART bit time (if STOPLEN = 0, one stop bit) or two bit times (if STOPLEN = 1, two stop bits) and check the value of the status bit again:
 - If status bit = 1, the receiver is idle.
 - If status bit = 0, the receiver is receiving data.
- If the status bit = 0, the receiver is receiving data.

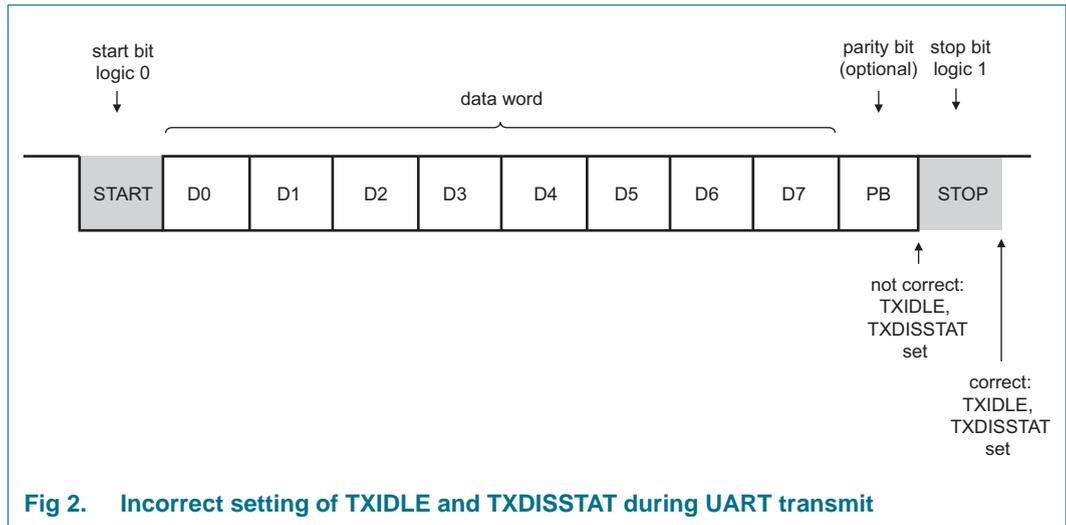
Both, TXIDLE and TXDISSTAT are set incorrectly between the last data bit and the stop bit while the transfer is still ongoing.

Fig 2. Incorrect setting of TXIDLE and TXDISSTAT during UART transmit
